INDOOR AIR QUALITY ASSESSMENT

**McCall Middle School
263 Main Street
Winchester, Massachusetts**

Prepared by:
Massachusetts Department of Public Health
Bureau of Environmental Health Assessment
Emergency Response/Indoor Air Quality Program
May 2003

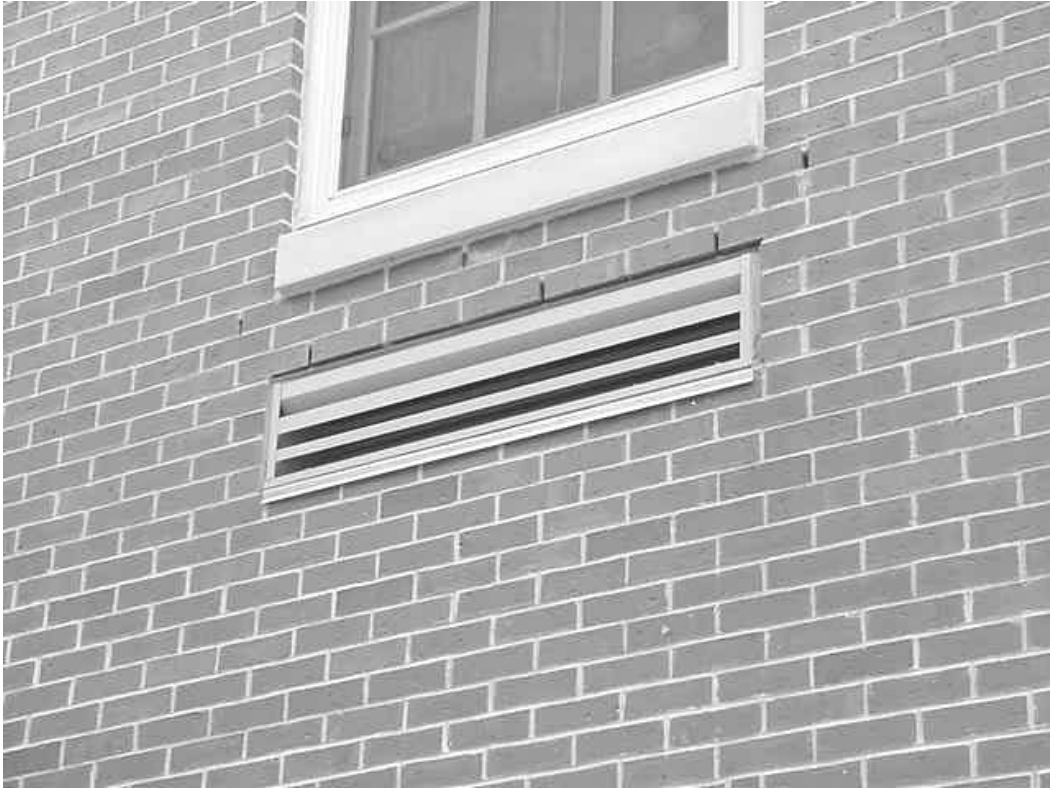
Picture 1

It can be seen from the tables that carbon dioxide levels were elevated above 800 parts per million parts of air (ppm) in four of thirty-two areas surveyed, indicating adequate ventilation in most areas of the school. Fresh air in classrooms is supplied by a unit ventilator (univent) system. Classroom temperature and airflow is controlled by a centralized computer system. Univents draw air from outdoors through a fresh air intake located on the exterior walls of the building (see Picture 1) and return air through an air intake located at the base of each unit (see [Figure 1](#)). Fresh air and return air are mixed,

Univent Air Intake

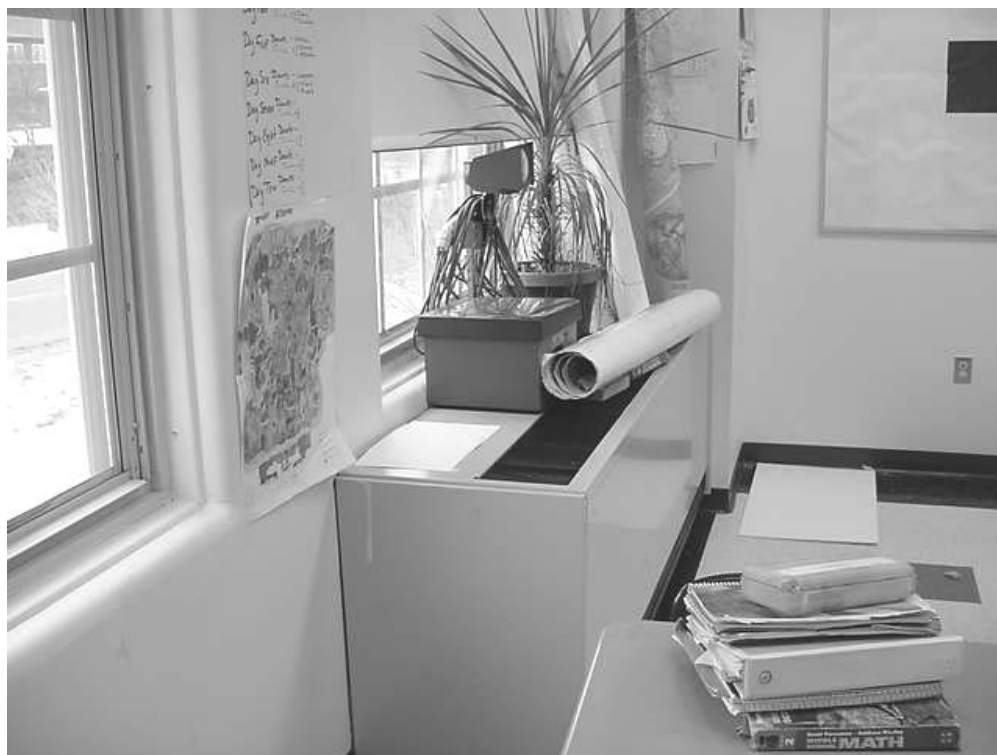
Picture 2

filtered, heated and distributed to classrooms through a fresh air diffuser located in the top of the unit. Univents were found deactivated or obstructed in a number of classrooms (see Tables/Picture 2), which can prevent airflow and lead to increased carbon dioxide levels. In order for univents to provide fresh air as designed, they must remain free of obstructions and allowed to operate.

Classroom Items on Univent Air Diffuser

1. Develop a clear line of communication between the central maintenance department and school personnel for prompt remediation of temperature and/or ventilation concerns/complaints. Classroom occupants should report temperature extremes immediately to school administration/maintenance and refrain from deactivating equipment.
2. To maximize air exchange, the BEHA recommends that both supply and exhaust ventilation *operate continuously* during periods of school occupancy.
3. Ventilation industrial standards recommend that mechanical ventilation systems be balanced every five years (SMACNA, 1994). Consult a ventilation engineer concerning re-balancing of the ventilation systems.
4. Remove all blockages from univents to ensure adequate airflow. Clean out interiors of univents regularly.

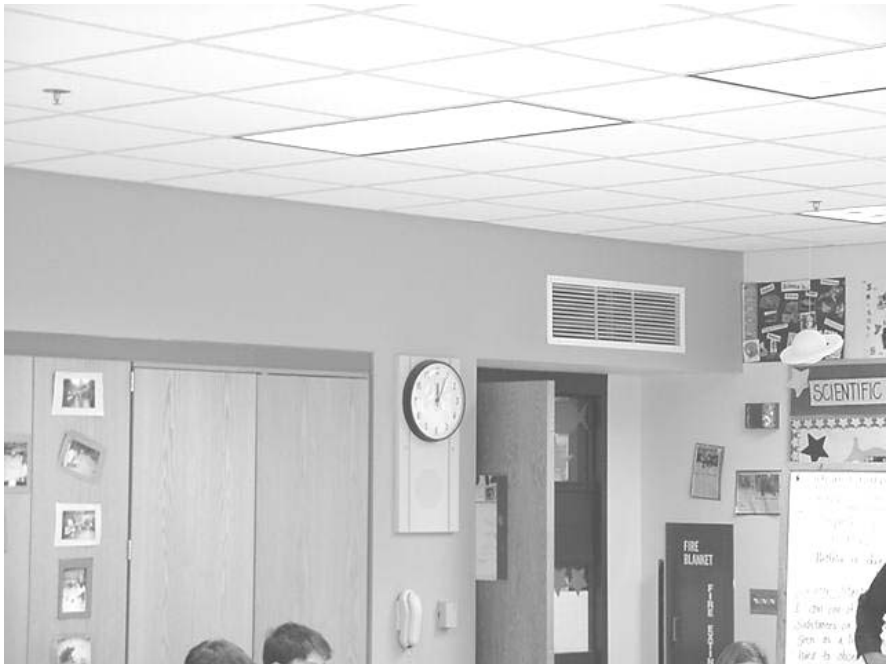
Picture 3

The mechanical exhaust ventilation system in classrooms consists of grated, wall or ceiling-mounted exhaust vents (see Picture 3). Exhaust air is expelled from the building by a motorized exhaust vent located on the roof (see Picture 4). These vents were operating throughout the building.

Classroom Exhaust Vent

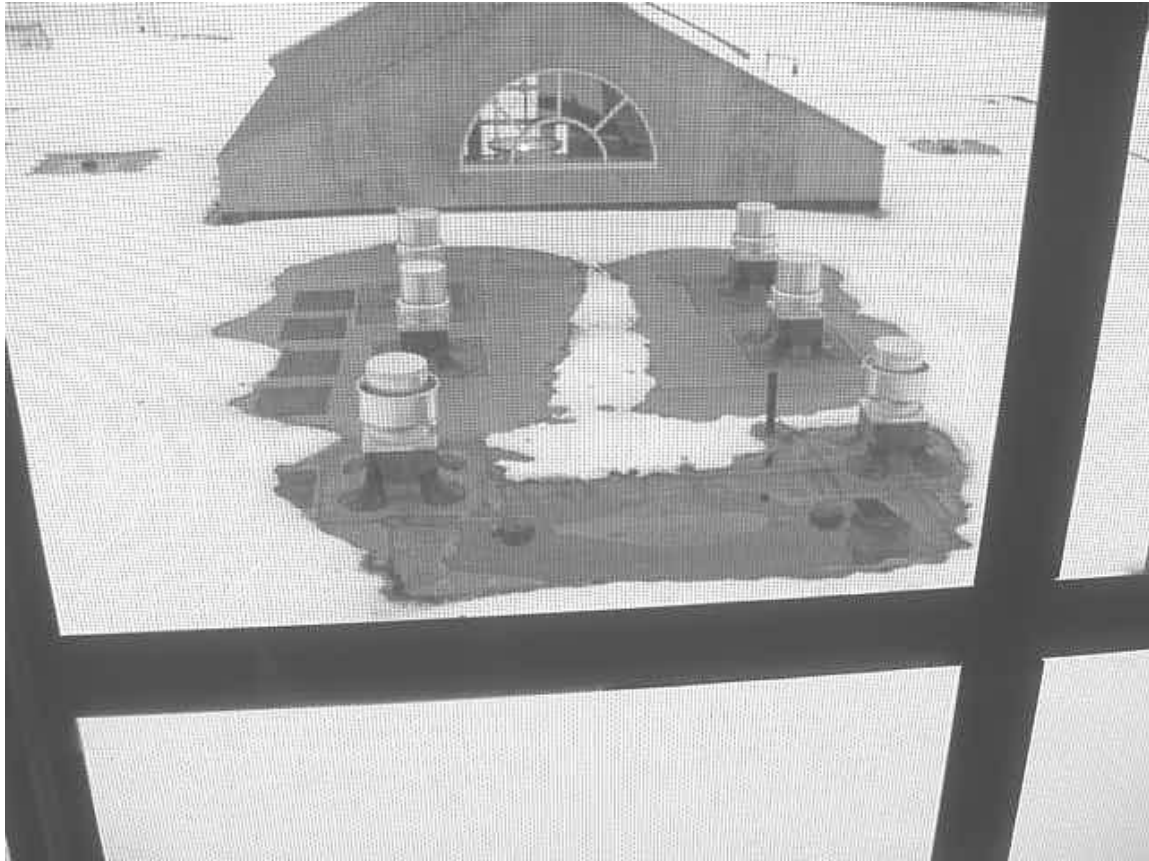
Picture 4

Rooftop Exhaust Motors, Note Melted Snow Indicating Operation

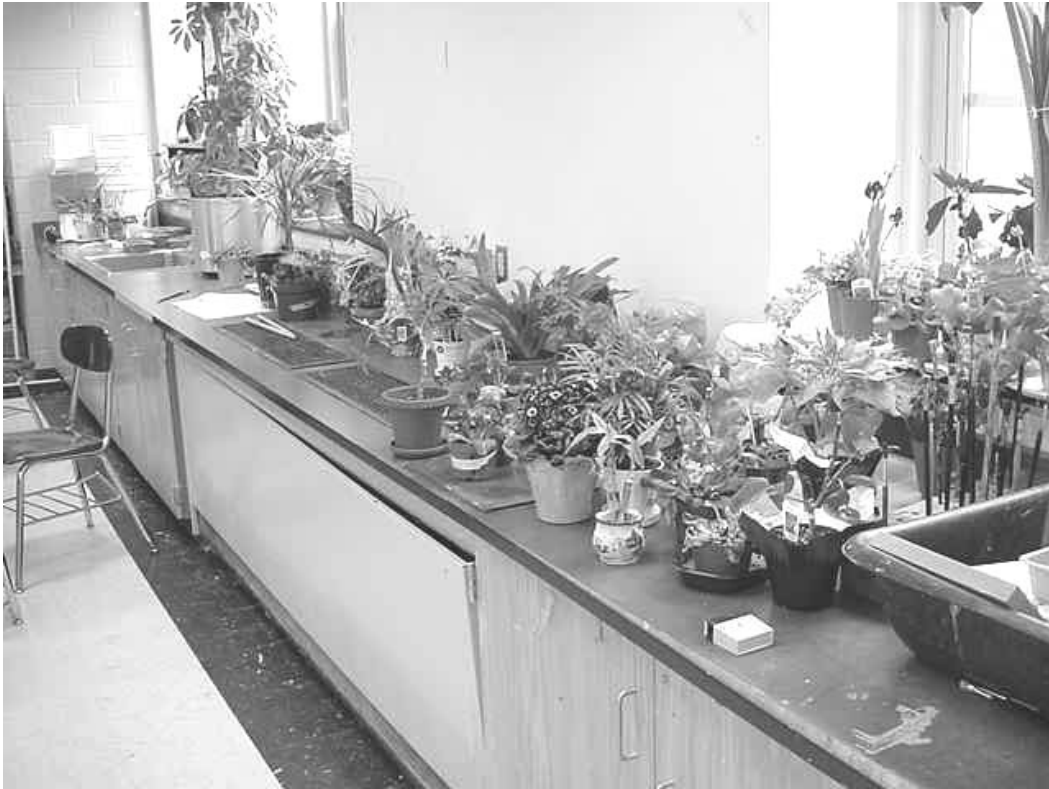
Picture 5

Several classrooms had a number of plants. Moistened plant soil and drip pans can be sources of mold growth. Plants are also a source of pollen. Plants in several classrooms were noted near univent air diffusers (see Picture 6-8). In some classrooms, plant debris and potting soil were seen on/inside univent air diffusers. Plants should be located away from the air stream of ventilation sources to prevent the aerosolization of mold, pollen or particulate matter throughout the classroom.

Flowering Plants on/near Classroom Univent

6. Remove plants from univents. Ensure plants have drip pans. Examine drip pans periodically for mold growth and disinfect with an appropriate antimicrobial where necessary.

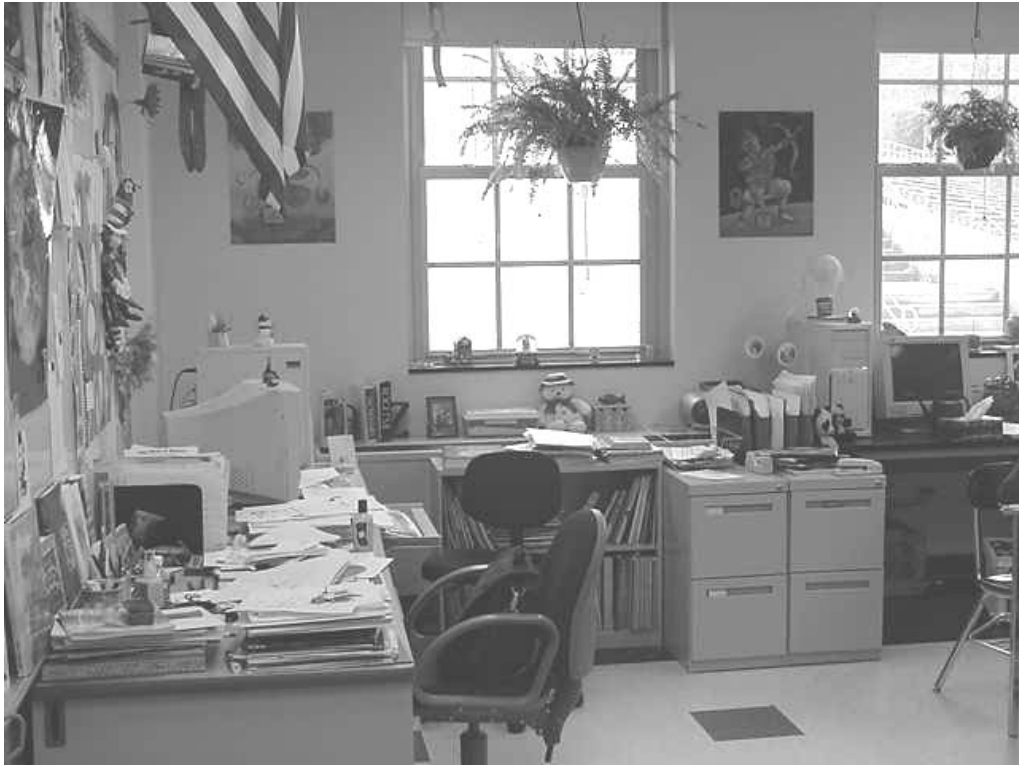
Picture 6

Hanging Plants above Univent Air Diffuser

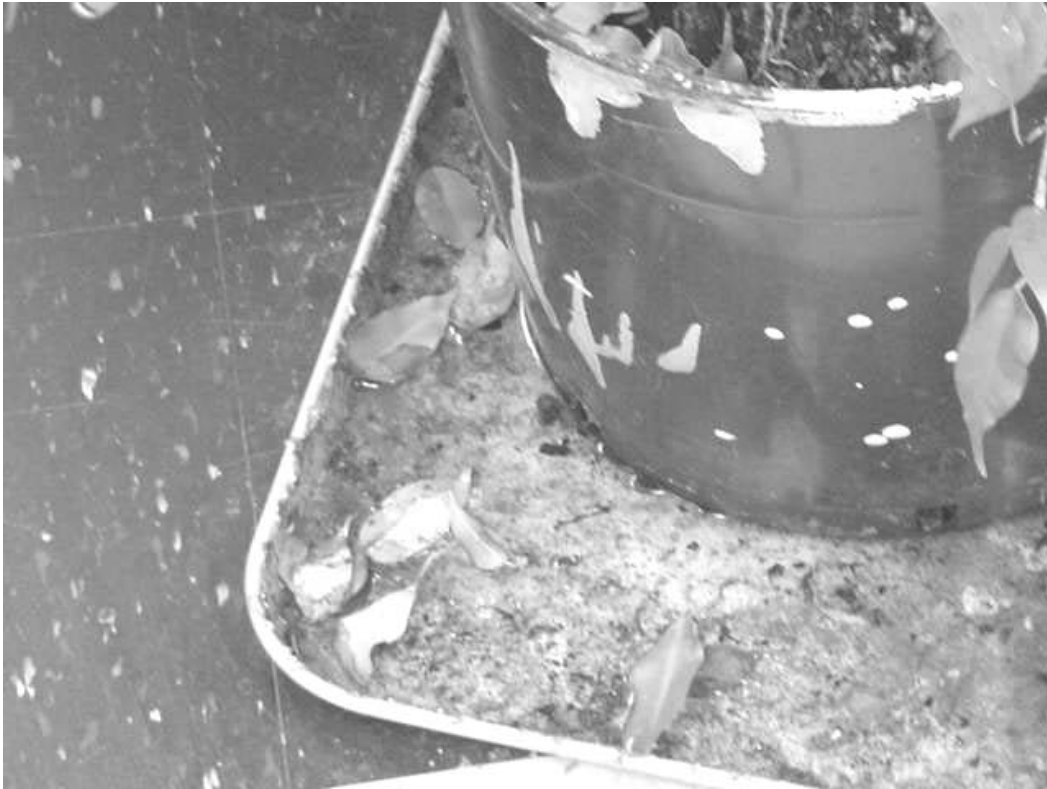
Picture 7

**Close-up of Standing Water/Mold Growth in Drip Pan of Plant on Classroom Floor
Near Univent Return Vent**

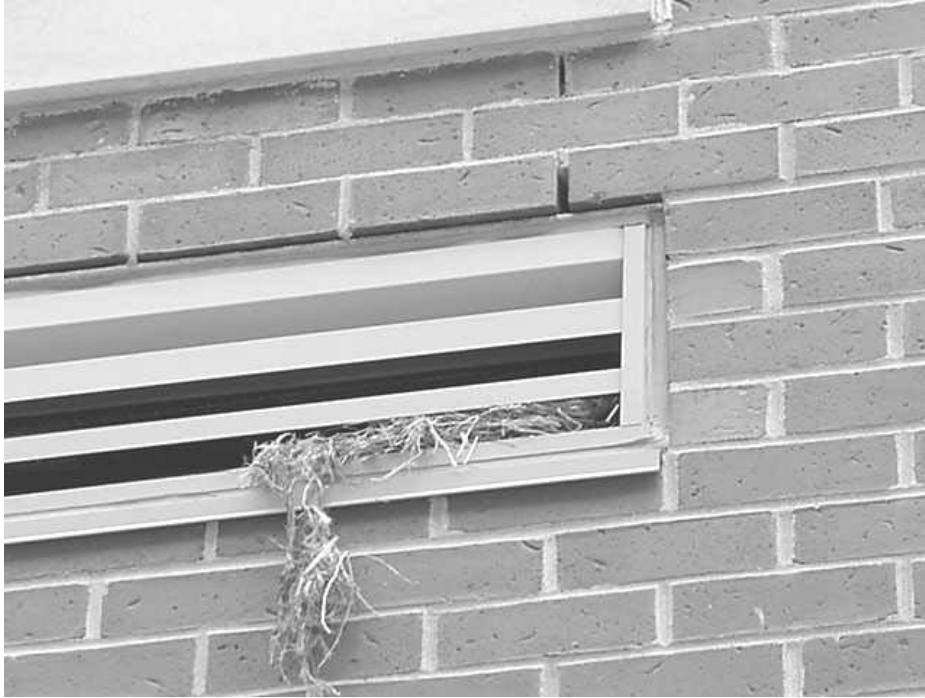
Picture 8

Signs of bird roosting and nesting materials were observed in the intake louvers of two univents (see Picture 5). These observations were verbally reported to Mr. Doucette and school principal Evander French on the day of the assessment. Mr. Doucette stated that the nests would be removed that day. BEHA staff recommended that the units be inspected for signs of bird wastes and thoroughly cleaned and disinfected as needed. Birds can be a source of disease, and bird wastes and feathers can contain mold and mildew, which can be irritating to the respiratory system. No obvious signs of bird roosting inside the building were noted by BEHA staff nor reported by occupants.

Bird Nesting Materials in Univent Air Intake

9. Remove bird's nests from univent air intakes. Inspect to ensure surfaces are free of nesting materials and bird wastes. Clean and disinfect with an appropriate antimicrobial where necessary.

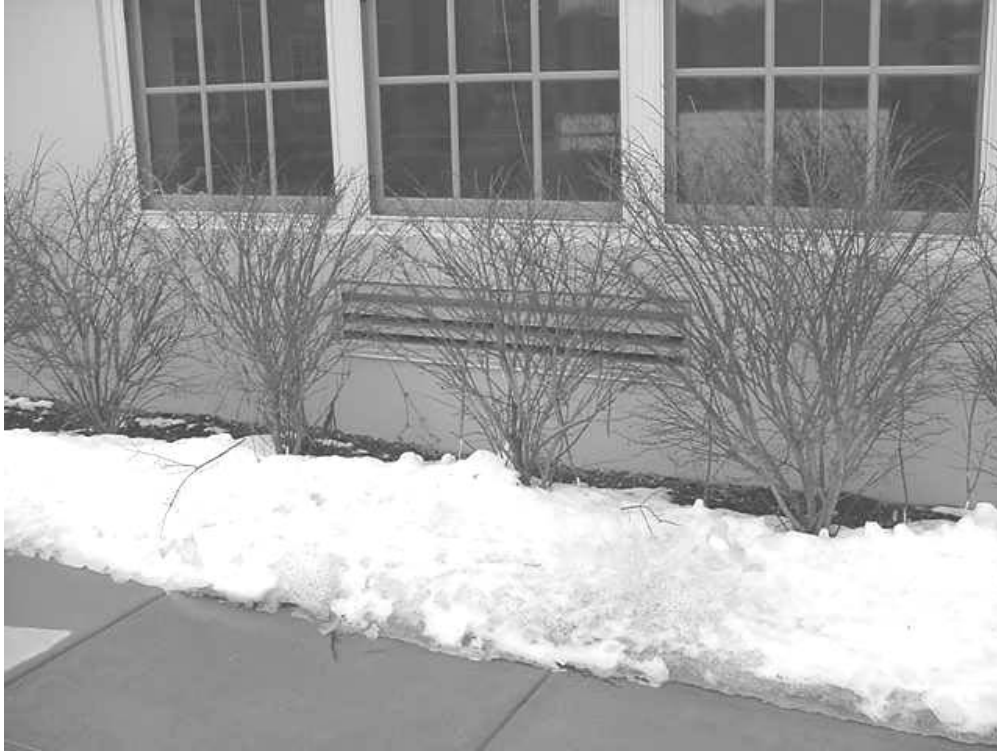
Picture 9

Along the perimeter of the building, shrubbery was growing in close proximity to univent air intakes (see Picture 9). Care should be taken to ensure that fresh air intakes remain clear of obstructions (e.g. shrubbery) to avoid the entrainment of dirt, moisture, pollen and/or other particulate matter.

Shrubbery in Close Proximity to Univent Air Intake

10. Trim plant growth away from air intakes to avoid the entrainment of moisture, pollen and mold.
11. In order to provide self assessment and maintain a good indoor air quality environment on your building, consideration should be give to adopting the US

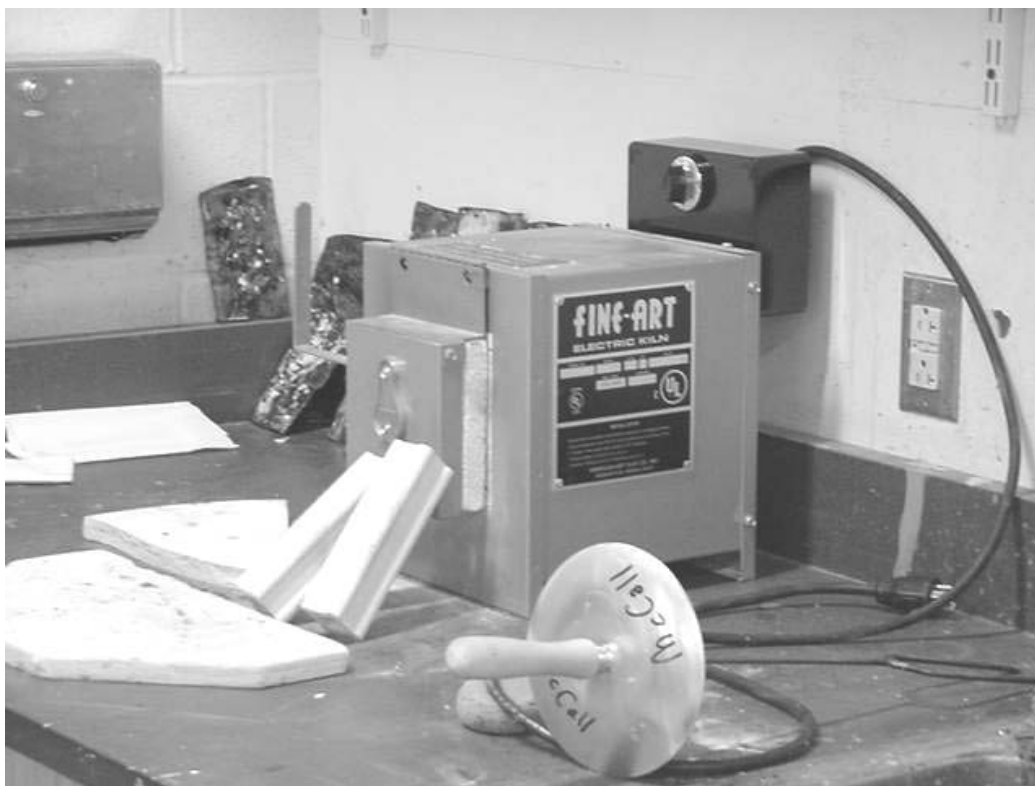
Picture 10

Several other conditions that can potentially affect indoor air quality were also identified. The art room contained a small jewelry kiln on a countertop (see Picture 10). No local exhaust ventilation appears to be provided for this equipment. Pottery kilns can produce carbon monoxide and sulfur dioxide, which can cause respiratory symptoms in exposed individuals. This area does however contain several pottery kilns that are equipped with local exhaust ventilation, located in an adjacent room (see Picture 11). BEHA staff recommended that the jewelry kiln be relocated to utilize local exhaust provided for the pottery kilns. This material can be easily aerosolized and serve as eye and respiratory irritants.

Small Jewelry Kiln

7. Consider discontinue the use of tennis balls on chairs to prevent latex dust generation.
8. Relocate jewelry kiln in art room to utilize local exhaust ventilation for pottery kilns (see Picture 11).

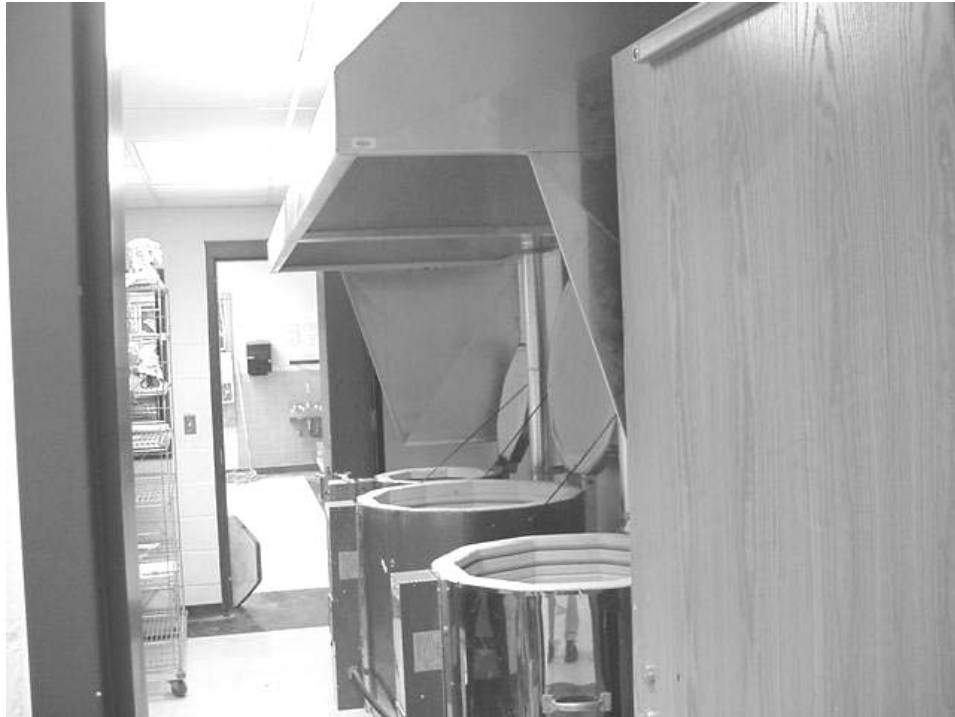
Picture 11

Local Exhaust Ventilation for Pottery Kiln

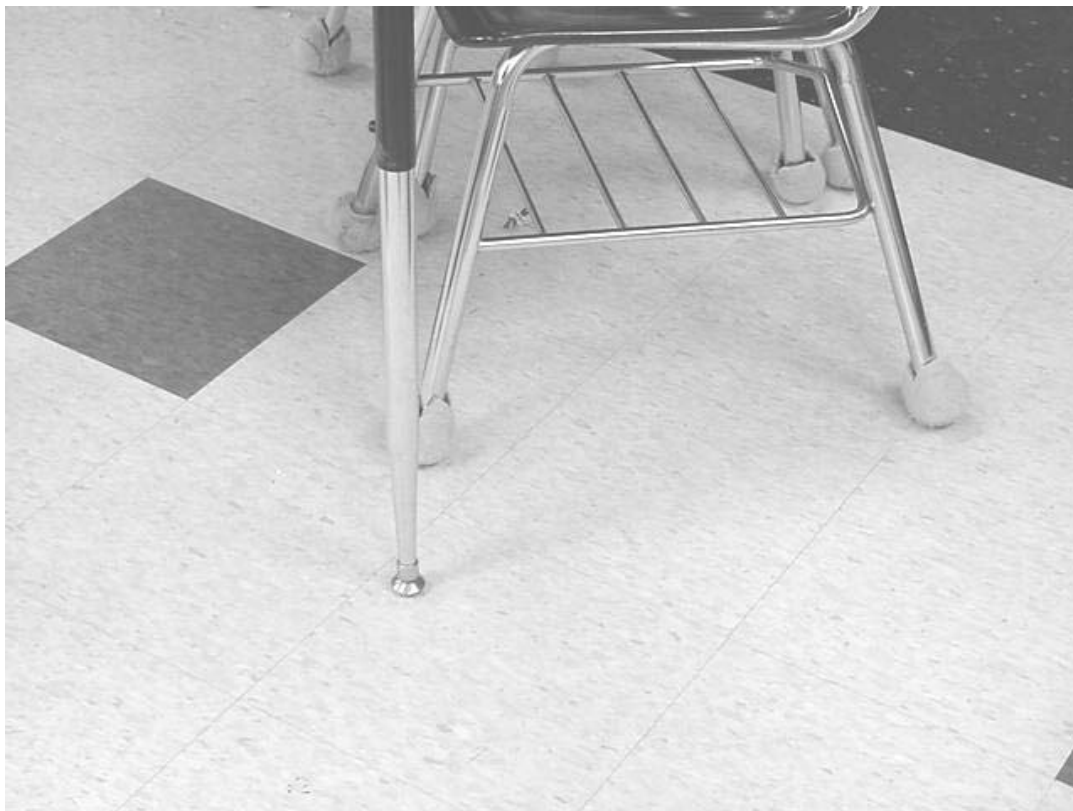
Picture 12

Finally, in an effort to reduce noise from sliding chairs, tennis balls had been sliced open and placed on chair legs (see Picture 12). Tennis balls are made of a number of materials that are a source of respiratory irritants. Constant wearing of tennis balls can produce fibers and to off-gas VOCs. Tennis balls are made with a natural rubber latex

bladder, which becomes abraded when used as a chair leg pad. Use of tennis balls in this manner may introduce latex dust into the school environment. Some individuals are highly allergic to latex (e.g., spina bifida patients) (SBAA, 2001). It is recommended that the use of materials containing latex be limited in buildings to reduce the likelihood of symptoms in sensitive individuals (NIOSH, 1997). A question and answer sheet concerning latex allergy is attached as Appendix II (NIOSH, 1998).

Tennis Balls on Chair Legs in Classroom
